CASE STUDY

FOUR TIMES THE LINER LIFE WITH IMPROVED OVERLAY PLATE

LOCATION	Western Australia
MINE TYPE	Iron Ore Mine
MACHINE	Scrubber Discharge Chute
PRODUCT	CME™ Wear Plate

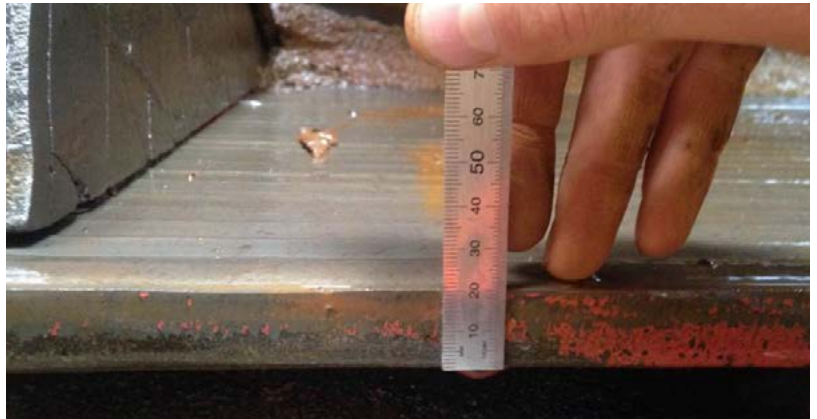
CME™ overlay liners after 2 weeks - no wear

The result was a remarkable improvement in wear rates. The CME™ overlay liners exceeded the life of the competitors' plate with only 0.10" (2.5 mm) wear on the leading edge after 12 weeks, resulting in the plant extending maintenance shutdowns to every 48 weeks, instead of 12 weeks. The chute is now protected from damage and no longer requires costly repairs during shutdowns. A significant reduction in the exposure to health and safety risks were also realized by the client through the reduced frequency of repairs.

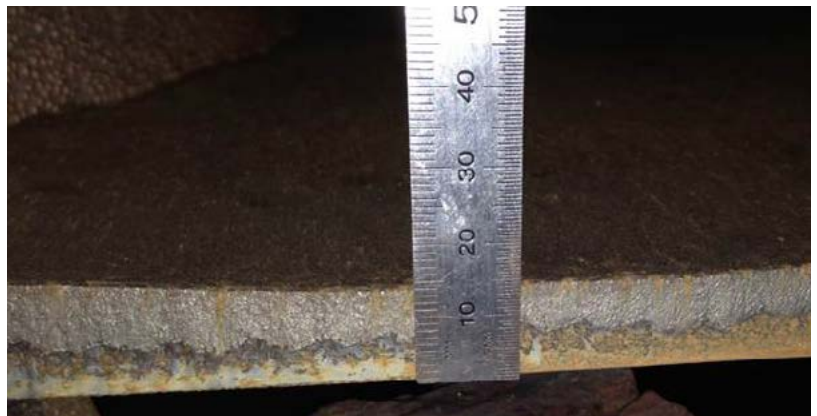
At an iron ore mine located in Western Australia, the customer had an ongoing issue with high wear rates in their scrubber discharge chutes. During each shutdown in a 12-week shutdown cycle, the existing 0.79" (20 mm) alloy-chromium carbide overlay plate supplied by a competitor was found to be completely worn through, resulting in damage to the exposed parent metal of the chute.

Competing plate after 2 weeks - 4mm of wear

The customer contacted H-E Parts to overcome the issue and after a thorough analysis of the wear situation, H-E Parts recommended improving the material selection by replacing the existing overlay plate with H-E Parts CME™ overlay liners, which are composed of one of the highest wear resistant materials produced in the world today.
