# CAT 793D SERVICE ISSUE IDENTIFICATION

**CASE STUDY**

Application | CAT 793D Haul Truck

Product | 793D Radiator

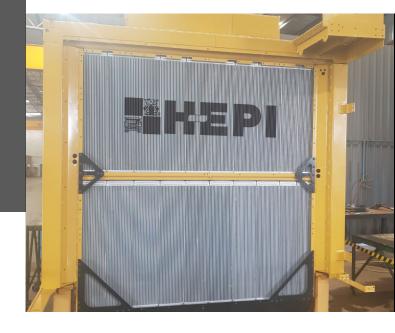
HEPI technicians recieved the cooling unit at our facility as part of our service exchange program. To determine the cause of the failure, the team cut and removed a section of the core for further analysis. After only a short service period, the core showed internal signs of severe corrosion and random pitting, indicating that it may have been exposed to stray current, resulting in premature wear, cracking and ultimately leading to the radiator failure. After initial testing using a multimeter was conducted, an on-site investigation found the engine was missing an earth strap to the chassis. This was causing stray current to pass through the radiator.

H-E Parts identified the cause of the failures, preventing the customer from further downtime due to a third install.
